REPORT NO: SY-139R-77
AIRTASK NO: A5345341/0532/7534000001
WORK UNIT NO: A53411-20
DATE: 13 July 1977

COPY NO. 45 **NAVAL AIR TEST CENTER**
REPORT OF TEST RESULTS

Test and Evaluation of AH-1T Forward Ground Handling Gear Assembly (P/N 209-052-244-1);
Second Report (Final)

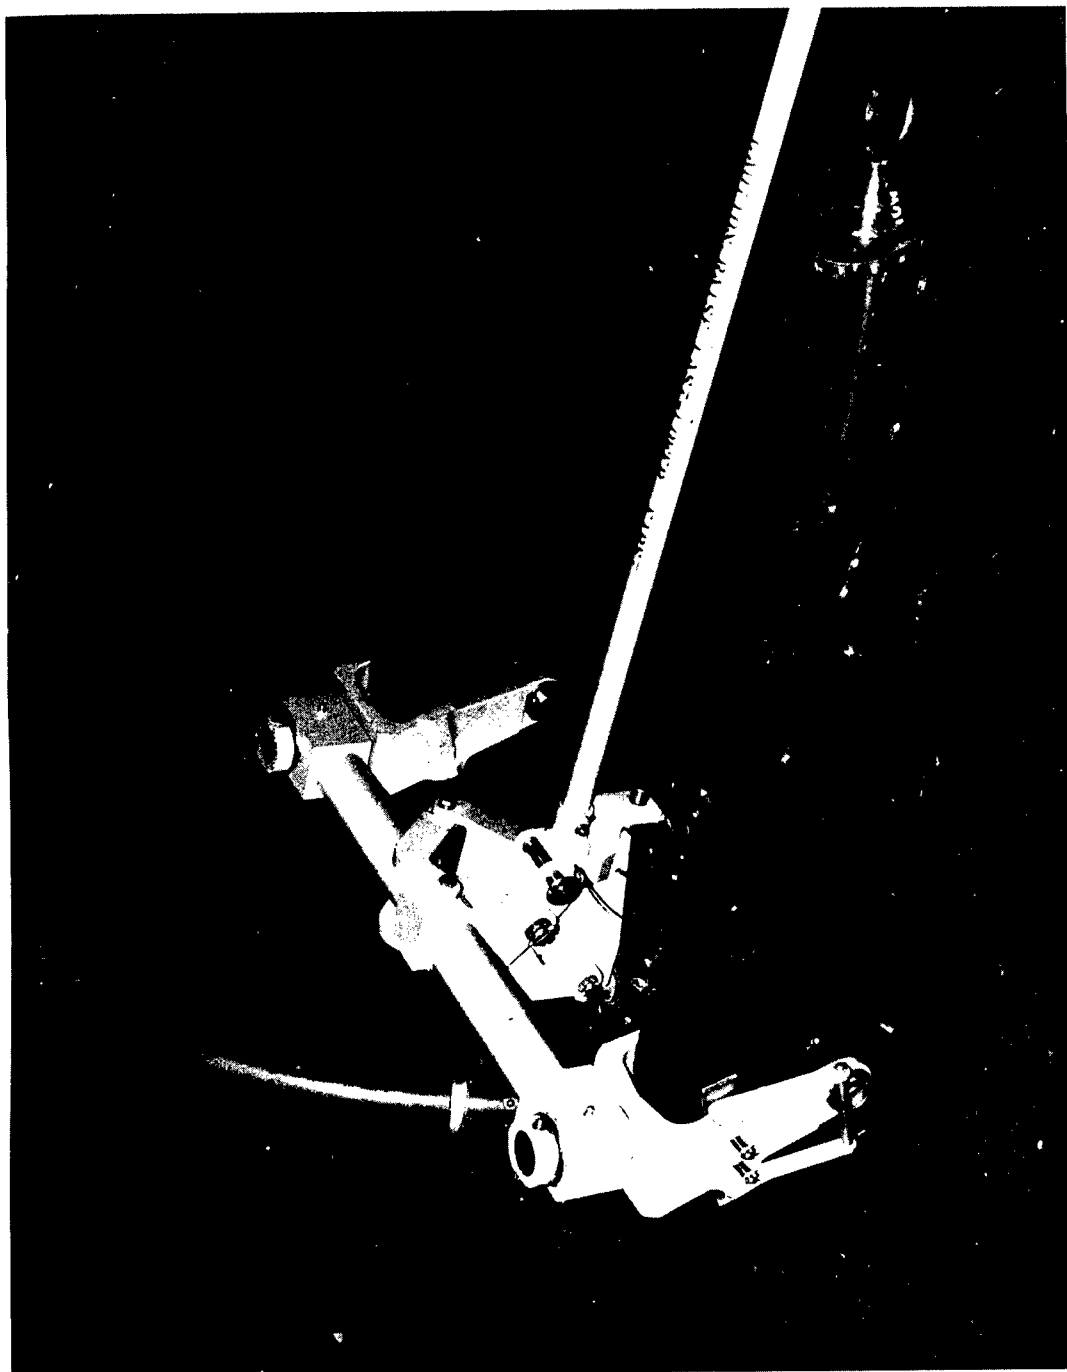
Figure 1
Forward Ground Handling Gear Assembly (P/N 209-052-244-1)

3. The Forward Ground Handling Gear Assembly (enclosure (1), figure 1) consists of two full castoring wheels connected by a common trunnion with a lift mechanism and a 36 in. (91.4 cm) lever handle. The Gear Assembly is attached to two lugs on the forward portion of each skid by means of a solid pin which engages the rear lug and a quick release pin that engages the front lug in the aircraft skid. The lever handle must be held straight up in a vertical position while installing the Gear Assembly, then rotated forward and down to the horizontal position to raise the front portion of the aircraft skid.
